RE: Copper Park Lane Work Completion  
Flambeau Mining Company

**Copper Park Lane - 2008 Work**

Copper Park Lane – 2008 Work

Photodocumentation

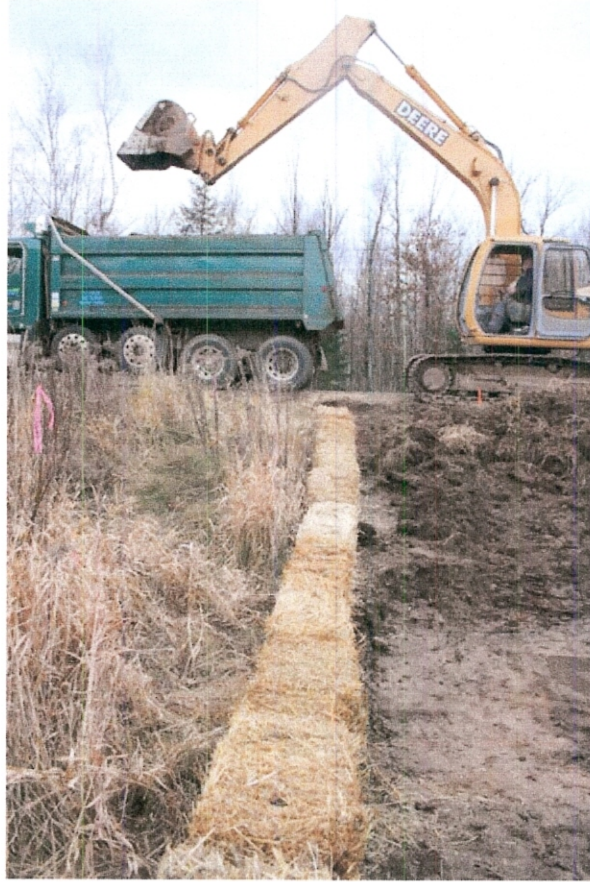
**Photograph 1.** On November 5, 2008 work began with the installation of a strawbale fence prior to excavation of surficial soils from the Copper Park Lane north ditch. Photo taken facing south.

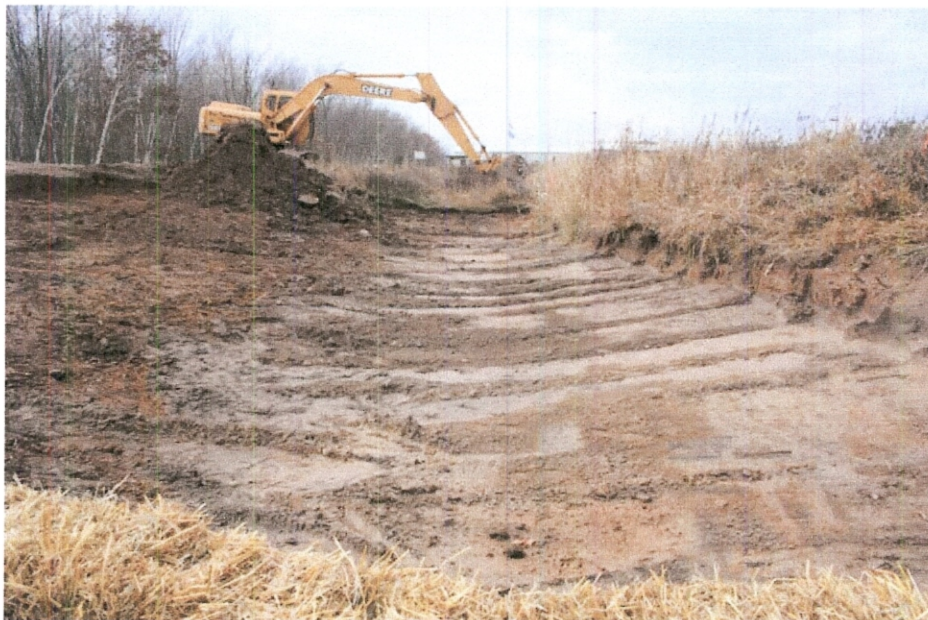
**Photograph 2.** The Copper Park Lane ditch surficial soils were excavated from east to west beginning on November 5, 2008. Photo taken facing west.

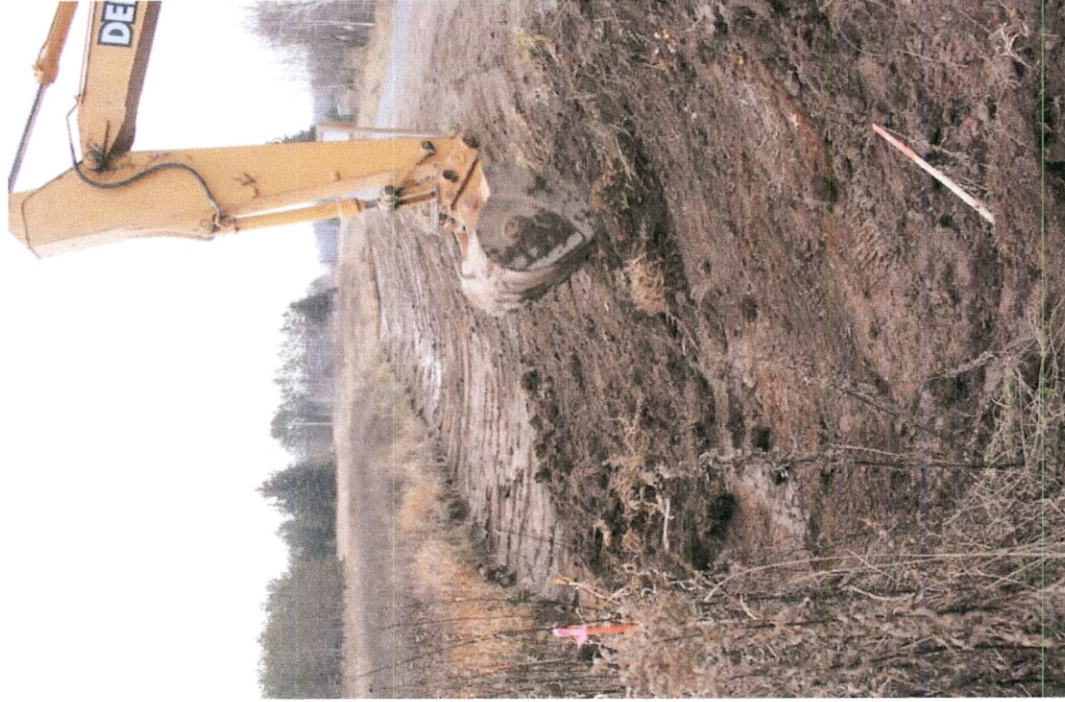
**Photograph 3.** Excavation of surficial soils was complete on November 6, 2008 ending at the western most end of the Copper Park Lane north ditch. Photo taken facing east.

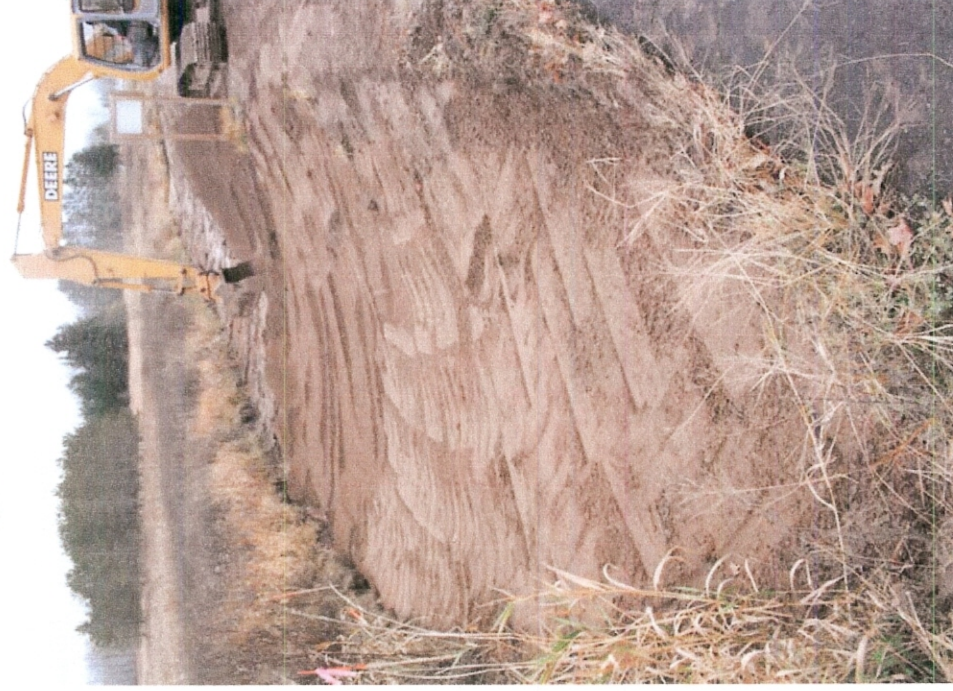
**Photograph 4.** Placement of clean gravel fill followed collection of confirmation sampling of sub-base. Placement of gravel fill was placed from west to east beginning November 6, 2008. Photo taken facing east.

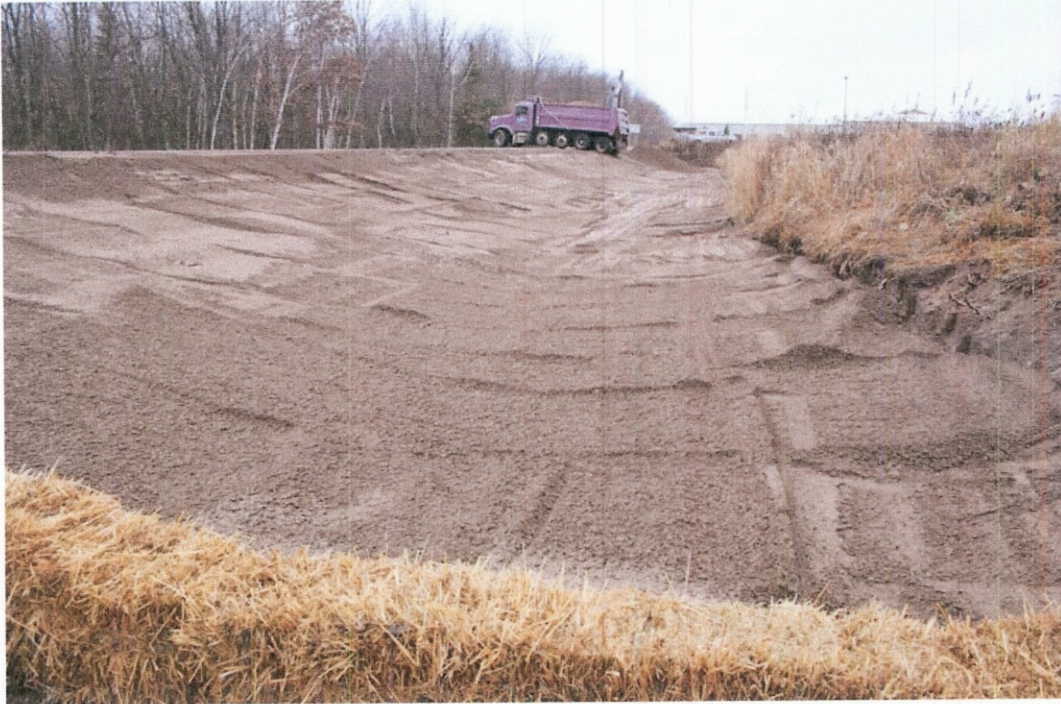
**Photograph 5. Placement of gravel fill was completed on November 7, 2008 and placement of topsoil was immediately begun. Photo taken facing west.**

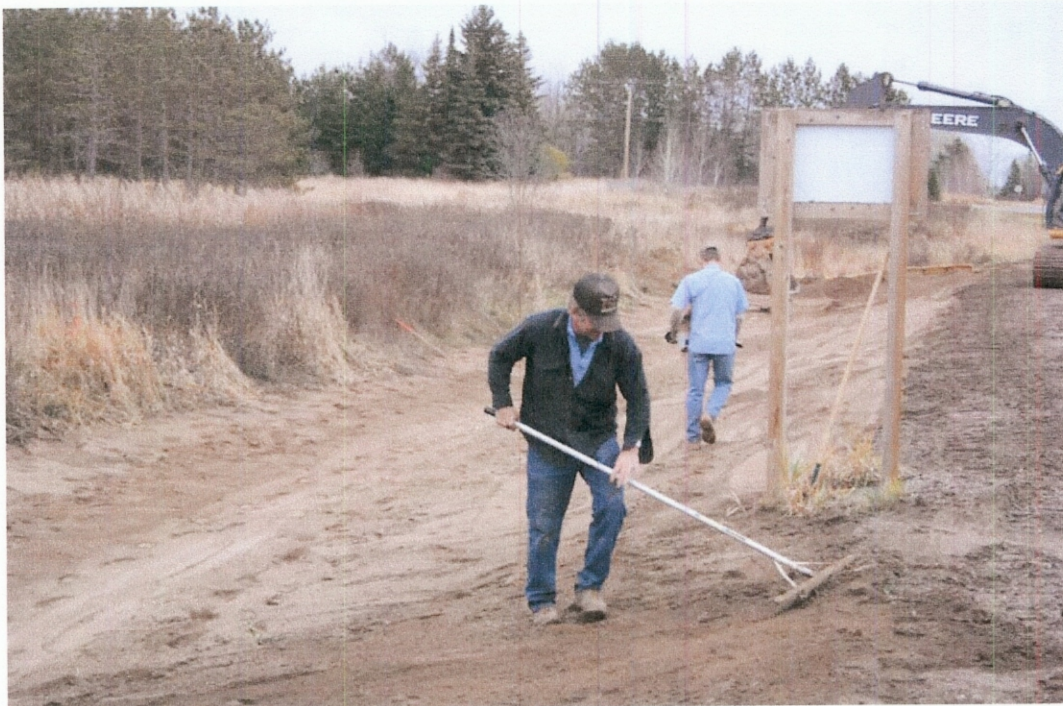
**Photograph 6. Placement of topsoil was completed on November 7, 2008. Hand rotary seeding and raking in of seed was completed as well on November 7, 2008. Photo taken facing east.**

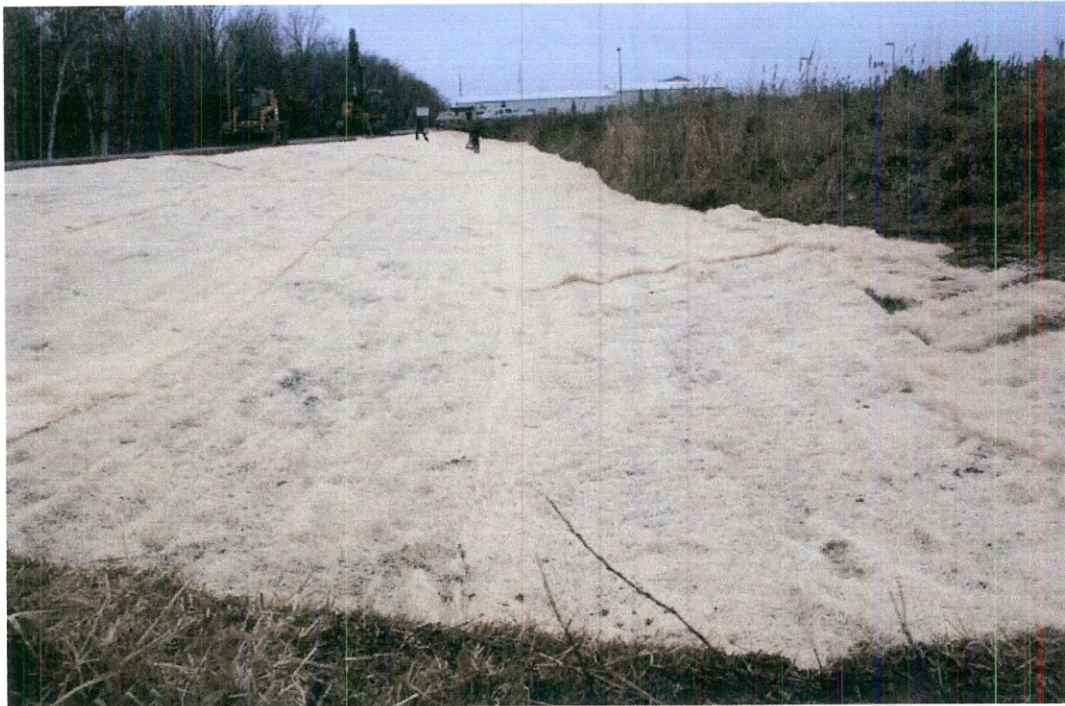
**Photograph 7. Netfree erosion control blanket was installed across the entire disturbance area and secured with biodegradable stakes by end of day November 7, 2008. Photo taken facing west.**
